Third Time's a Charm

These Concrete Floor Professionals Only Had One Shot to Get it Right

FOOD PROCESSING PLANT FLOOR

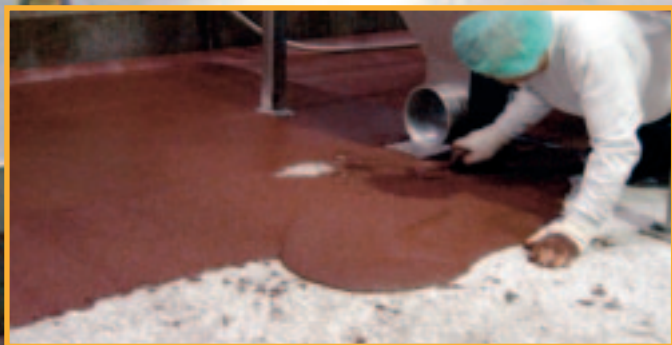
It's no fun going over someone else's work, especially when it involves removing a previously installed fiberglass-based floor coating in a refrigerated work space. A Concare crew member (above) lays down a single coat of Valspar's Thermo-Rok, a heavy-duty polyurethane/cementitious floor system. When scarifying, shotblasting, and grinding won't do, coatings professionals call in the "big guns" (background) in the form of a ride-on Surf Prep EM-1400 electric milling machine.

Concare turned to an old ally, Surf Prep, a Wisconsin-based concrete surfacing specialty company. Surf Prep rolled out its EM-1400 electric milling machine. The milling machine contains a cylindrical cutter that acts like a planer to remove up to two inches of concrete.

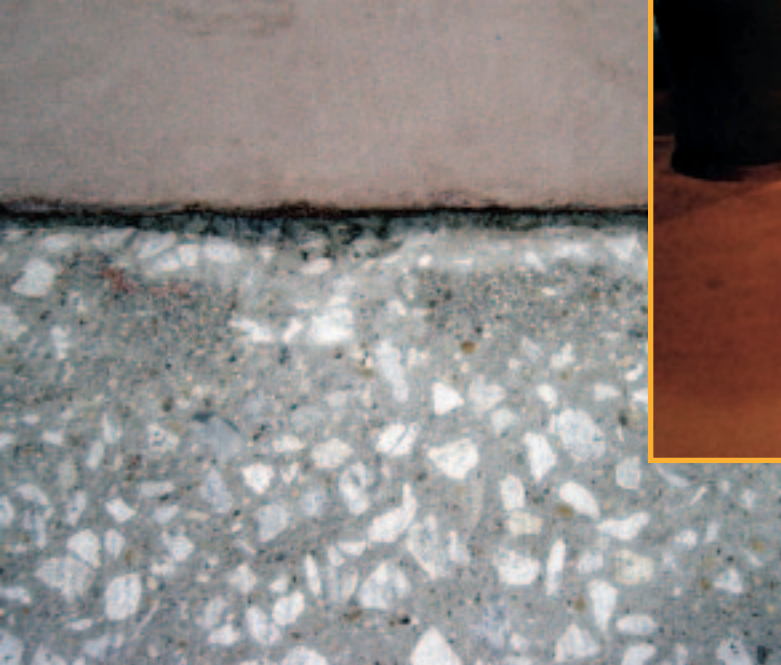
Troweling a 3,500-square-foot floor in one day — to the thickness of $\frac{3}{8}$ " (above) — takes coordination and teamwork. Part of the pressure to get this job right is illustrated by the delaminations visible in the old floor (right), caused in part by repeated thermal shock cycles associated with scrubbing cold floors with hot water. Beyond tripping and slipping safety hazards, such areas may attract and hold harmful bacteria.

Thickness was controlled by using a Valspar 30” wheeled screed, adjustable to help regulate the amount of material applied. After the floor was installed, joints were cut with a Sawtec pneumatic diamond saw to prevent the new floor from cracking.

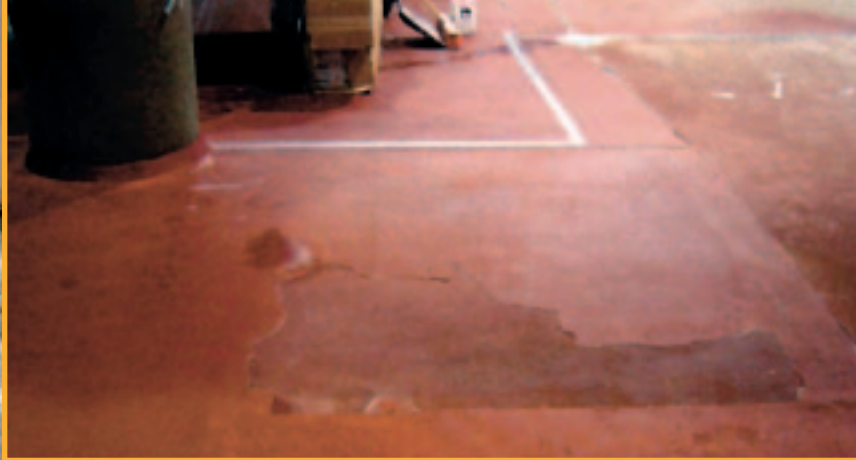
"The area was a 3,525-square-foot refrigerated space in which hot water and steam were used to clean containers and, ultimately, the floor itself," explained Concare president Ron Puszynski. He theorized that the persistent problem was from thermal shock cycling going on between the hot water and cool floors. Thermal shock cycling is the repeated application of a cold medium onto a hot surface, and vice versa. Thermal shock is the same force that can crack a hot dinner plate when it's thrust into cold water.

"It was apparent that thermal cycling — hot water and steam on cold floors — was the primary reason for the failure of the original floor," Puszynski said. "So we decided to use a urethane mortar product to give protection against thermal cycling. In addition, the urethane mortar has excellent slip resistance. You get an inherently slip-resistant floor that doesn't rely on additional aggregates to get a good profile."

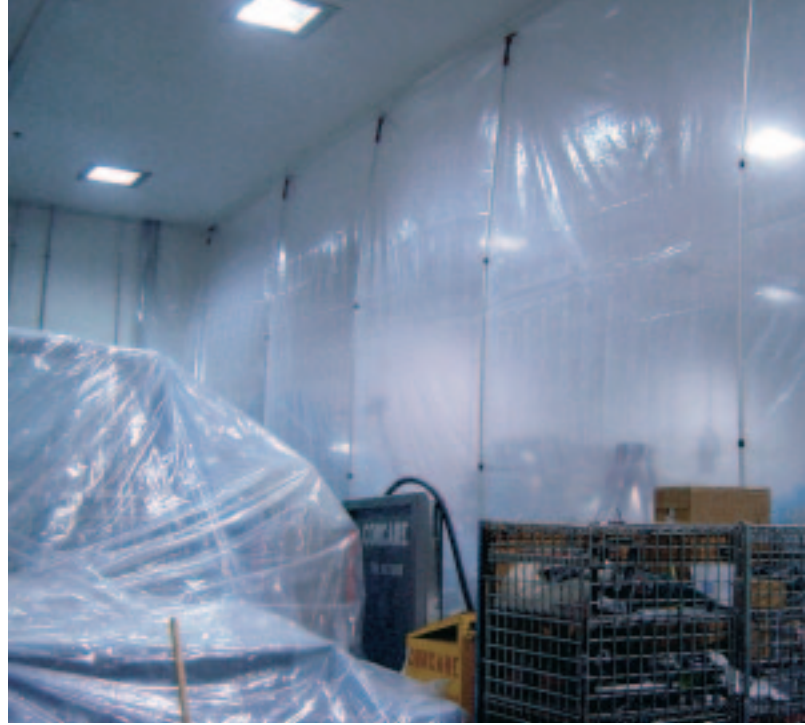
Prior to milling, plastic was used to shroud areas and sensitive equipment from dust. The milling — which included a pass with a shotblaster to clean the surface and remove all contaminants — took 10 hours from start to finish.

After the client removed all food products and covered all sensitive equipment with plastic, Surf Prep set to work. Ten hours later, the floor was milled.

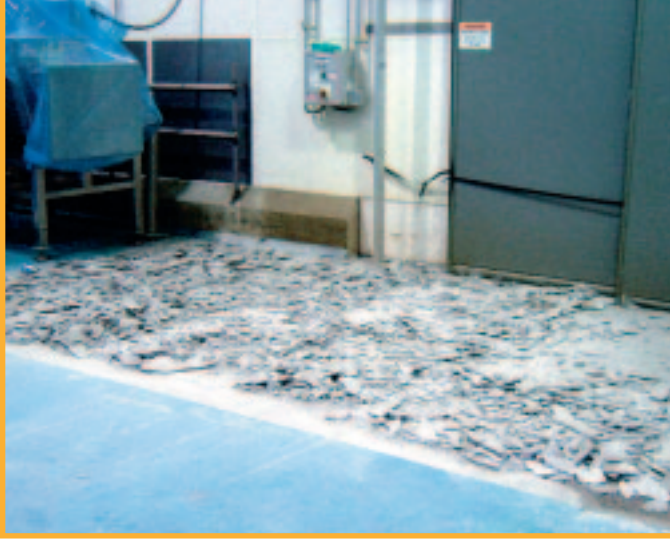
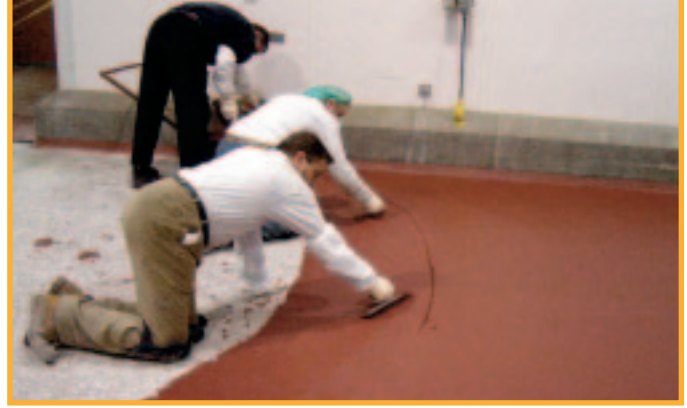
“Milling around” is all in a day’s work for Wisconsin-based Surf Prep, who used its heavy-duty cylindrical cutter to remove up to two inches of old coating (left). The debris was captured with a ride-on sweeper and vacuum cleaner; the surface was then shotblasted to remove any remaining contaminants.

After milling, most heavy debris was removed with a ride-on sweeper. The fine dirt and debris was removed with SASE-brand Bull 65 vacuum cleaners. The debris was placed in containers and taken to a landfill.

With Surf Prep’s milling job complete, the Concare crew went over the floor with a Goff 15E13 shotblaster to clean the surface and remove loose contaminants.
